Burpham Church Fabric Report 2021

St Luke's Church

Church of the Holy Spirit

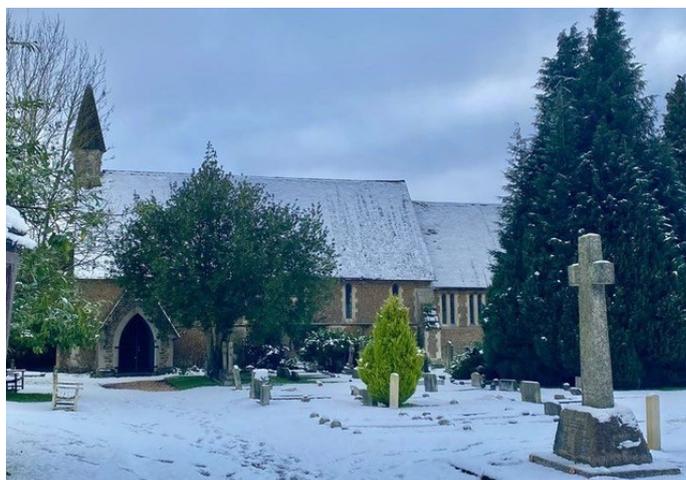
Otherwise the main issue at St Luke's remains the need to re-roof the whole church replacing the supporting battens, bearing in mind we have twice applied for a grant to help fund the work, but have been unsuccessful. The rate of deterioration of the roof is slow, but it is very difficult to assess how much longer it will last. The gutters and downpipes were cleaned and temporarily repaired in 2019 and further cleaning etc (after blockages we believe caused by pigeons!) was undertaken early in 2021.

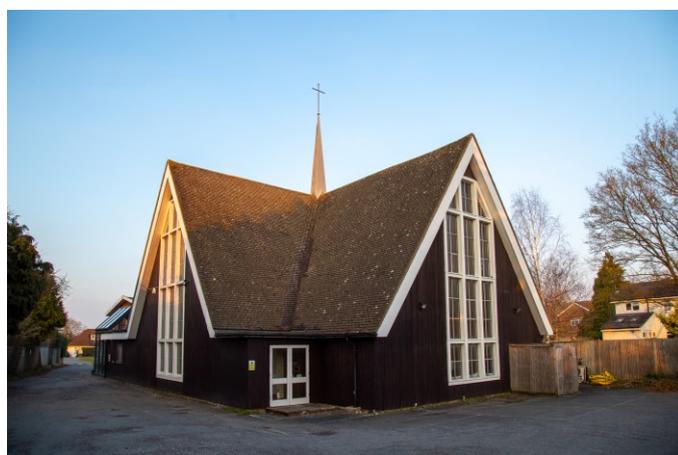
CHS has been in greater use than in 2020 but still significantly affected by Covid. In person services began again in March but for most of the year seriously reduced in both number and what could take place in the service. Social distancing and monitoring of CO² levels became very much the norm. There have been relatively few issues requiring immediate attention but the south window had further work sealing in the glass in the windows into its metal sub-frame. [While this worked satisfactorily in 2021, Storm Eunice in 2022 led to further water ingress and the contractor has agreed to investigate the problem and undertake further work to seal the windows.]
