Burpham Church Fabric Report 2017

St Luke's Church

Quinquennial Inspection

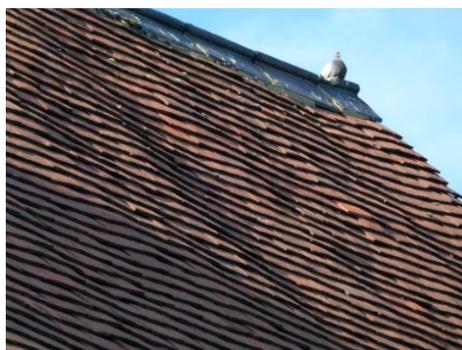
As in the previous inspection in 2012 the biggest item was the need to re-roof the whole church replacing the supporting battens, although it was felt many of the tiles could be reused. It has been previously reported that we have twice applied for a Roof Grant for this work but on both occasions were unsuccessful.

The undersized battens which are failing are the cause of the undulations which can be seen in the roof. The inspecting architect has recommended that this work be carried out within two years, although he also commented that the issue was being raised in an inspection as long ago as 1990 so the problem has existed for some time, and the rate of deterioration is difficult to assess.

At the same time it is recommended that work is done to the rainwater drainage system and the bellcote. There were a number of other less significant issues raised.

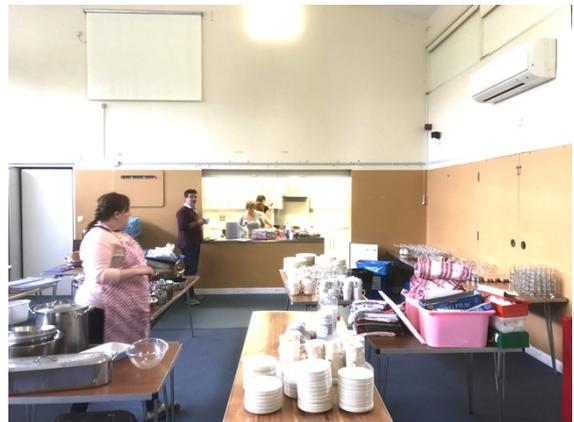
- For some time we have wished to improve the kitchen and in particular put in a dishwasher capable of properly washing the dishes etc after our functions. After successfully raising the funds this was set in hand for the summer and was linked to a major sort-out and clean-up in the kitchen by members of the church family, as seen in the picture. It took some time to complete the electrics and work surfaces associated with the new dish washer, but it has now been operational for several months and is greatly appreciated.

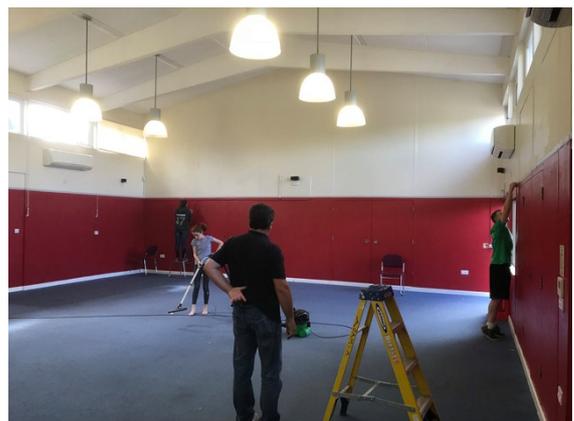
- The paintwork in the hall had become damaged and rather tired (and not everyone liked the colour at the lower level from when the hall was renovated in 2009!). Again volunteers worked to transform the hall in August (as seen in the second picture), and it is much improved as a result.
